Effect of touch-up paint

Introduction

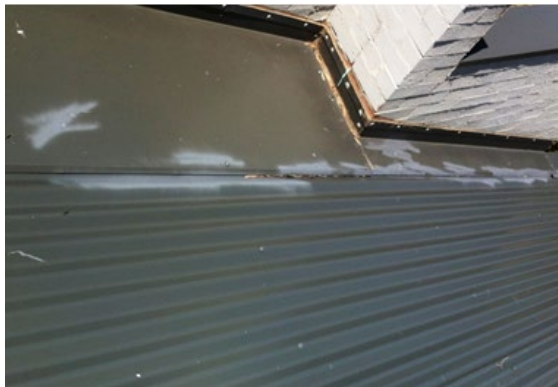
During manufacture, COLORBOND® prepainted steel undergoes a curing process in which the paint is baked onto the metallic coated steel substrate; while other paint systems, for example aerosol sprays, are air dried. Air-drying paints have different weathering characteristics to oven cured, prepainted products like COLORBOND® steel. Therefore, areas overpainted with air-drying paints to match adjacent COLORBOND® steel areas will weather at a different rate and vary in appearance over time (Figures 1 and 2).

Figure 1. Irregular faded appearance of touch-up paint on roof flashing and roofing broad sheet

BlueScope does not recommend the use of touch-up paint to repair damage or scratches to the painted surface. As explained above, air-drying paints have different weathering characteristics to COLORBOND® steel, which leads to variations in appearance over time where touch-up paint has been used. BlueScope does not have a recommended method for the removal of touch-up paint. Minor scratches (< 2mm in width) should be left alone as the available metallic coating will continue to protect against corrosion providing the scratches are superficial and the metallic coating is not damaged. If scratches are more noticeable on new material, it is the recommendation of BlueScope to replace the affected product.

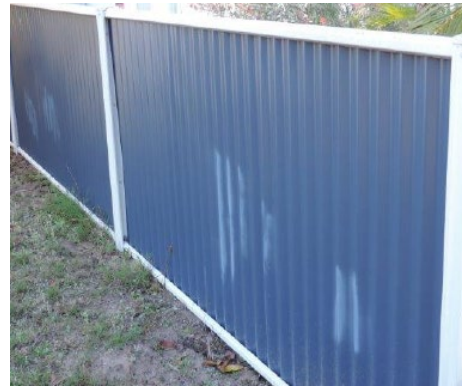
Figure 2. Irregular faded appearance of touch-up paint on fencing panels

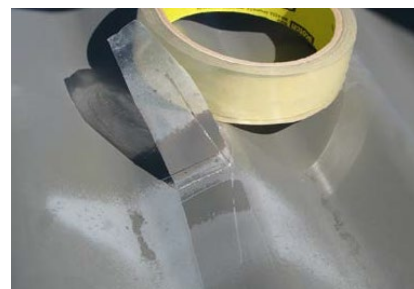
Adhesive tape can be pressed onto the surface of the defect and rapidly removed. Upon removal the tape may show retained paint on its adhesive surface. Where the tape has been removed from the material, the faded area is also removed showing the original colour underneath (Fig. 3).

Figure 1. Tape-off showing colour of original painted surface beneath a removed surface layer of faded

The application of touch-up paint, after installation of the various COLORBOND® steel components, can explain the irregular faded appearance of the COLORBOND® steel. The relative ease with which the surface layer is removed to reveal the original colour beneath (via adhesive tape and/or rubber eraser) is another indication that touch-up paint has been used.

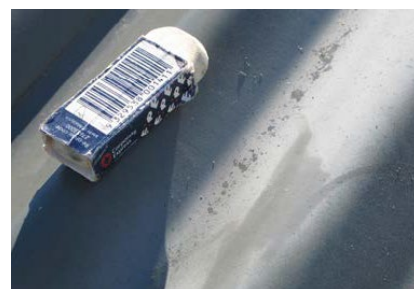
A rubber eraser can be used on a section of the material that has the faded appearance. This test will show the partial removal of the faded surface layer revealing the colour of the original painted surface beneath (Fig. 4).

Figure 2. Rubber eraser showing colour of original painted surface beneath a removed surface layer of faded appearance
